# DAM SAFETY INSPECTION REPORT

Woodside Lake Dam

File Number: 1005-008

Inspection Date: April 19, 2016

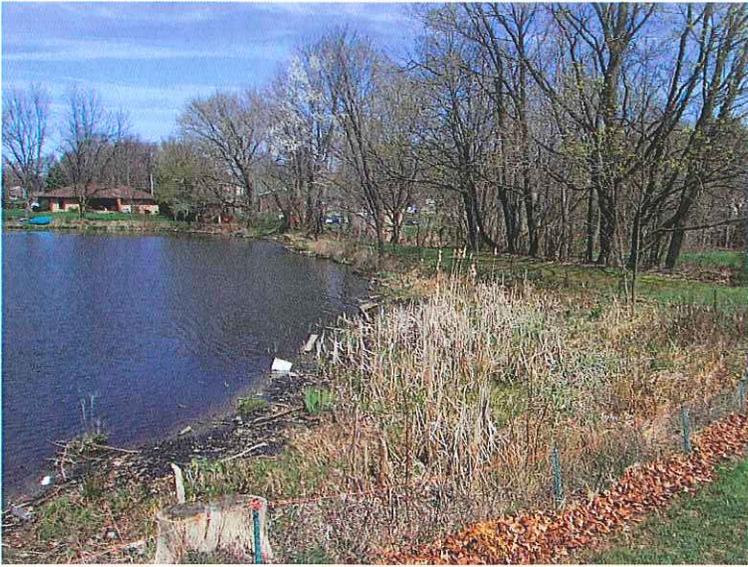
Photograph No. 1: View of the upstream slope from the right abutment. Note the tall vegetation growing on the slope.

- Trees and brush along slope
- Tall vegetation along slope
- Rodent burrows along shoreline

- No owner repairs for this report.
- Trees and brush are not permitted on embankment surfaces or earthen spillways.  
*Clear the trees, brush, and tall vegetation from the entire embankment and establish a healthy grass cover on the dam.*
- The embankment crest must have a uniform elevation.  
*Level the crest.*
- Rodent burrows weaken dam embankments and must be repaired. Rodent activity must be controlled.  
*Eliminate the rodent population and repair the rodent burrows on the dam.*
- The embankment and spillways must be protected from erosion. A healthy grass cover should be present on embankment and spillways as needed, and rock riprap must be cleared of vegetation and replenished periodically.

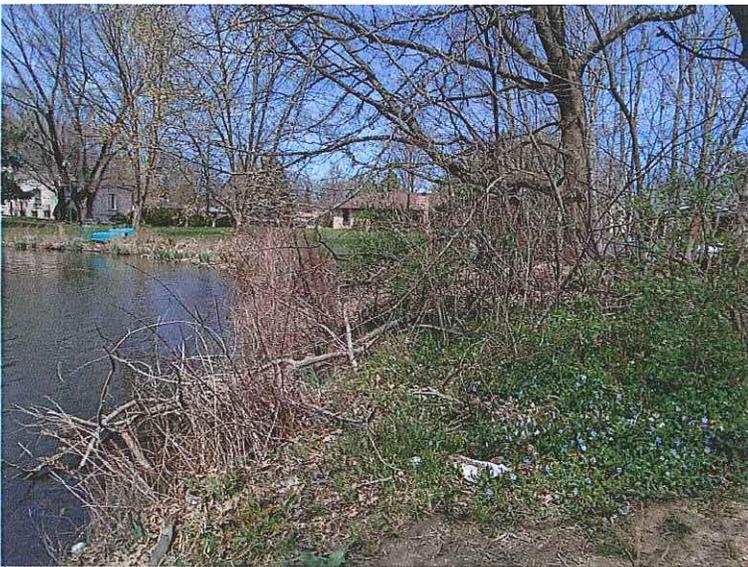
Photograph No. 2: Another view of the upstream slope.

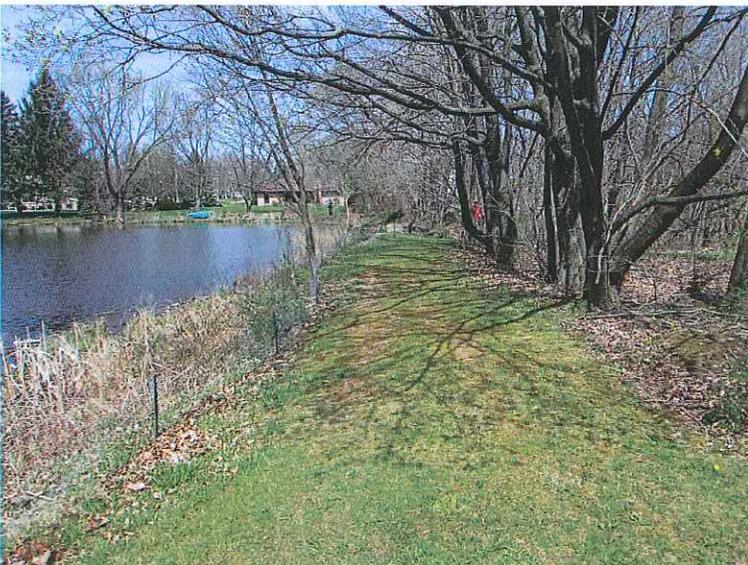
Photograph No. 3: View of the crest from the right abutment.

- Trees and brush
- Multiple low areas along crest
- Sparse areas of grass on right half

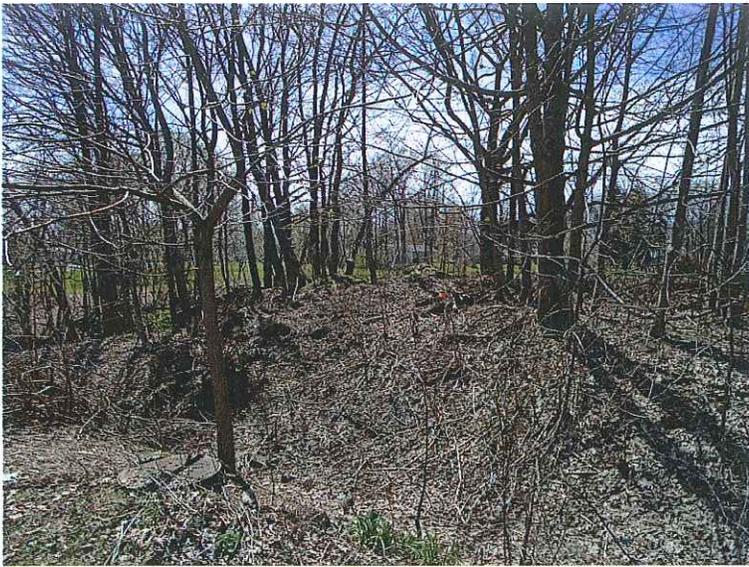
Photograph No. 4: View of the downstream slope from the left end of the dam. Note the trees and brush on the slope.

- Trees and brush along entire slope
- Debris dumped onto downstream slope
- Severe erosion on slope were seepage through cutoff wall is occurring

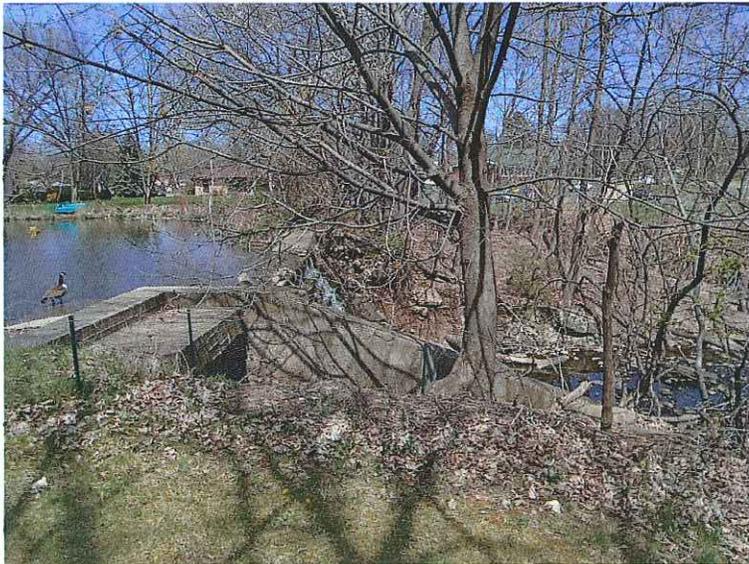
Photograph No. 5: View of the downstream slope from the left end of the dam.

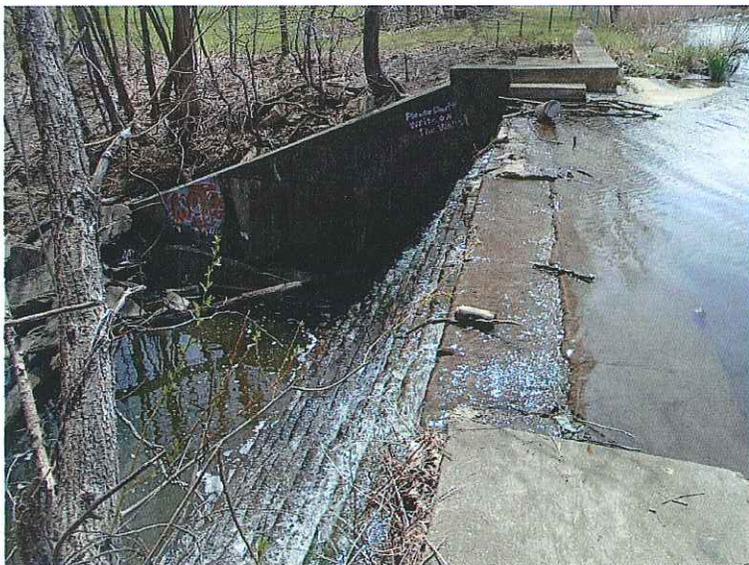
Photograph No. 6: View of the principal spillway weir.

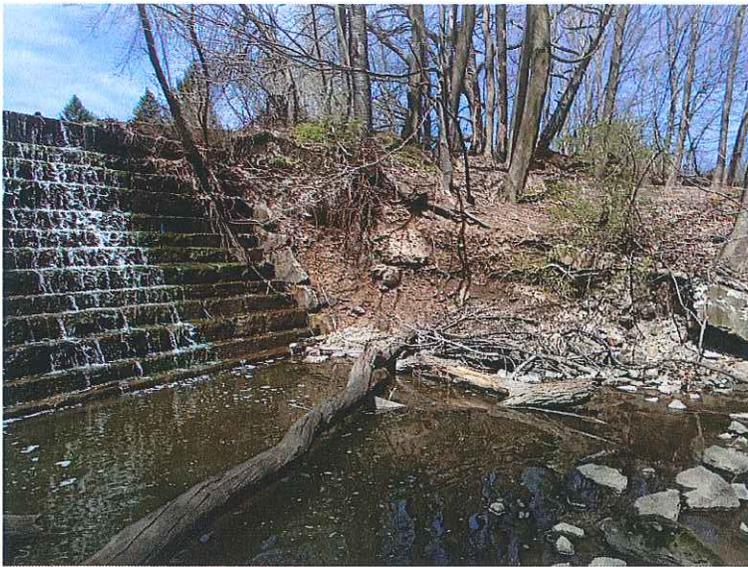
Photograph No. 7: View of the principal spillway. Note the right sidewall has collapsed and has been washed downstream.

- Left sidewall collapsed and washed away
- 150 GPM leaking through concrete behind right sidewall
- Seepage through right sidewall
- Uneven weir
- Severe damage to right sidewall

2. The entire spillway system must be replaced. Prepare plans and specifications for replacement of the spillway system. The condition of the spillway system must be monitored monthly and during large storm events for further deterioration. This item should be completed in coordination with Item 1 above.

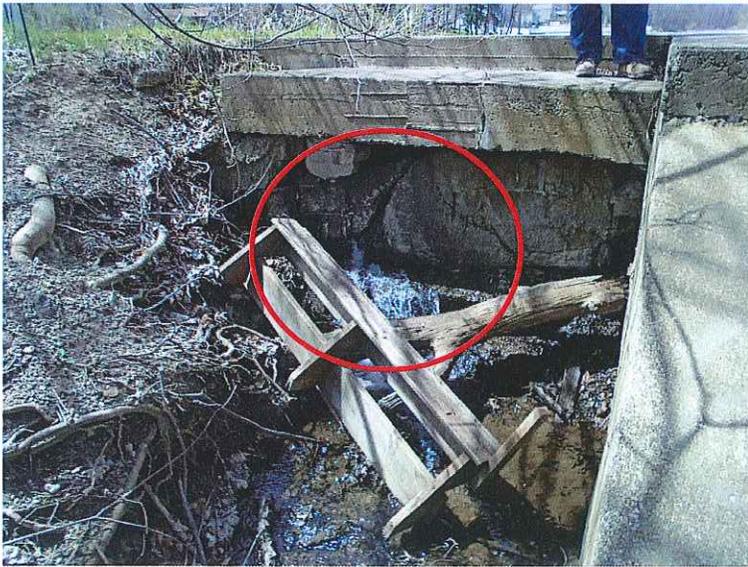
Photograph No. 8: View behind the left sidewall of the principal spillway. Note the large crack in the concrete and the large amounts of water seeping through.

3. The stability of the embankment must be maintained. Prepare plans and specifications for the repair of the concrete cutoff wall to the right of the right principal spillway sidewall, for the compacted fill that needs to be placed on the downstream slope where the seepage has eroded the slope, and for the installation of a seepage drain pipe behind the right principal spillway sidewall. The crack in the cutoff wall and overall stability of the embankment must be monitored monthly and during large storm events.

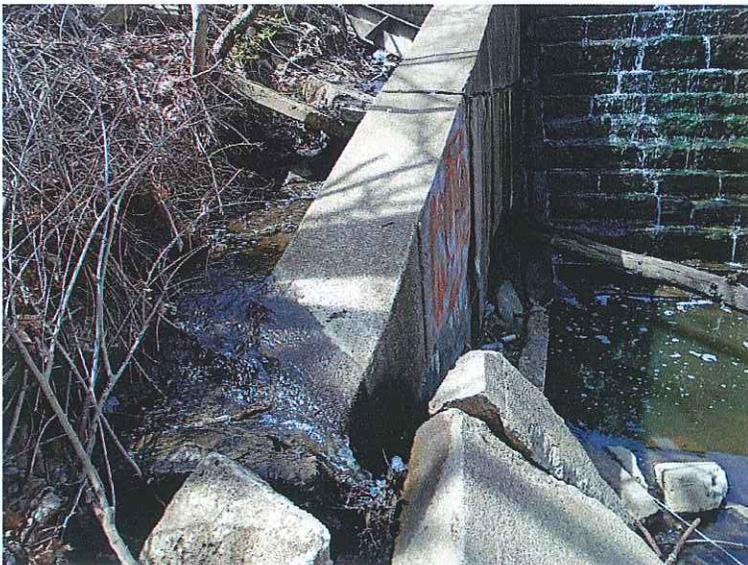
Photograph No. 9: View of the left sidewall. The water leaking from the crack in the picture above is eroding the soil behind the sidewall and seeping through cracks in the sidewall.

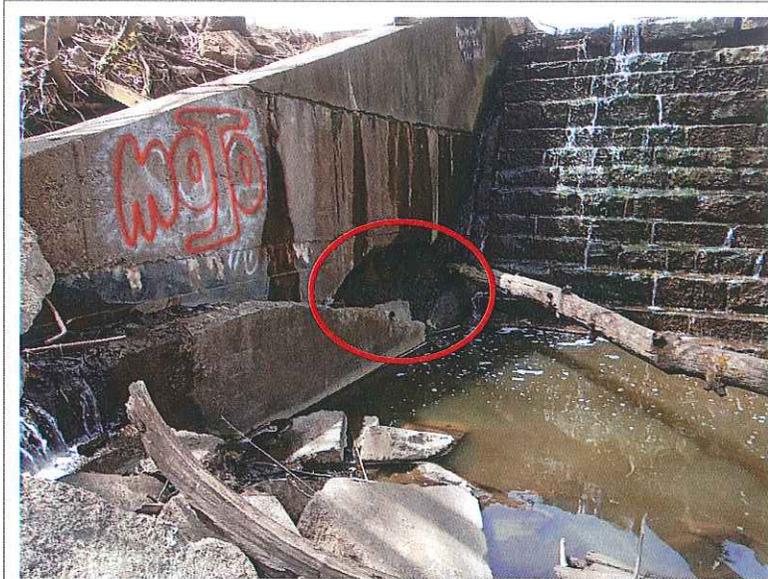
Photograph No. 10: Another view of the left sidewall. Note the severe damage to the concrete.
